A Tale of Cows, Dogs, Sewage and Cooperation

Solving Problems in Lime Lake

Molly Rippke – Michigan EGLE

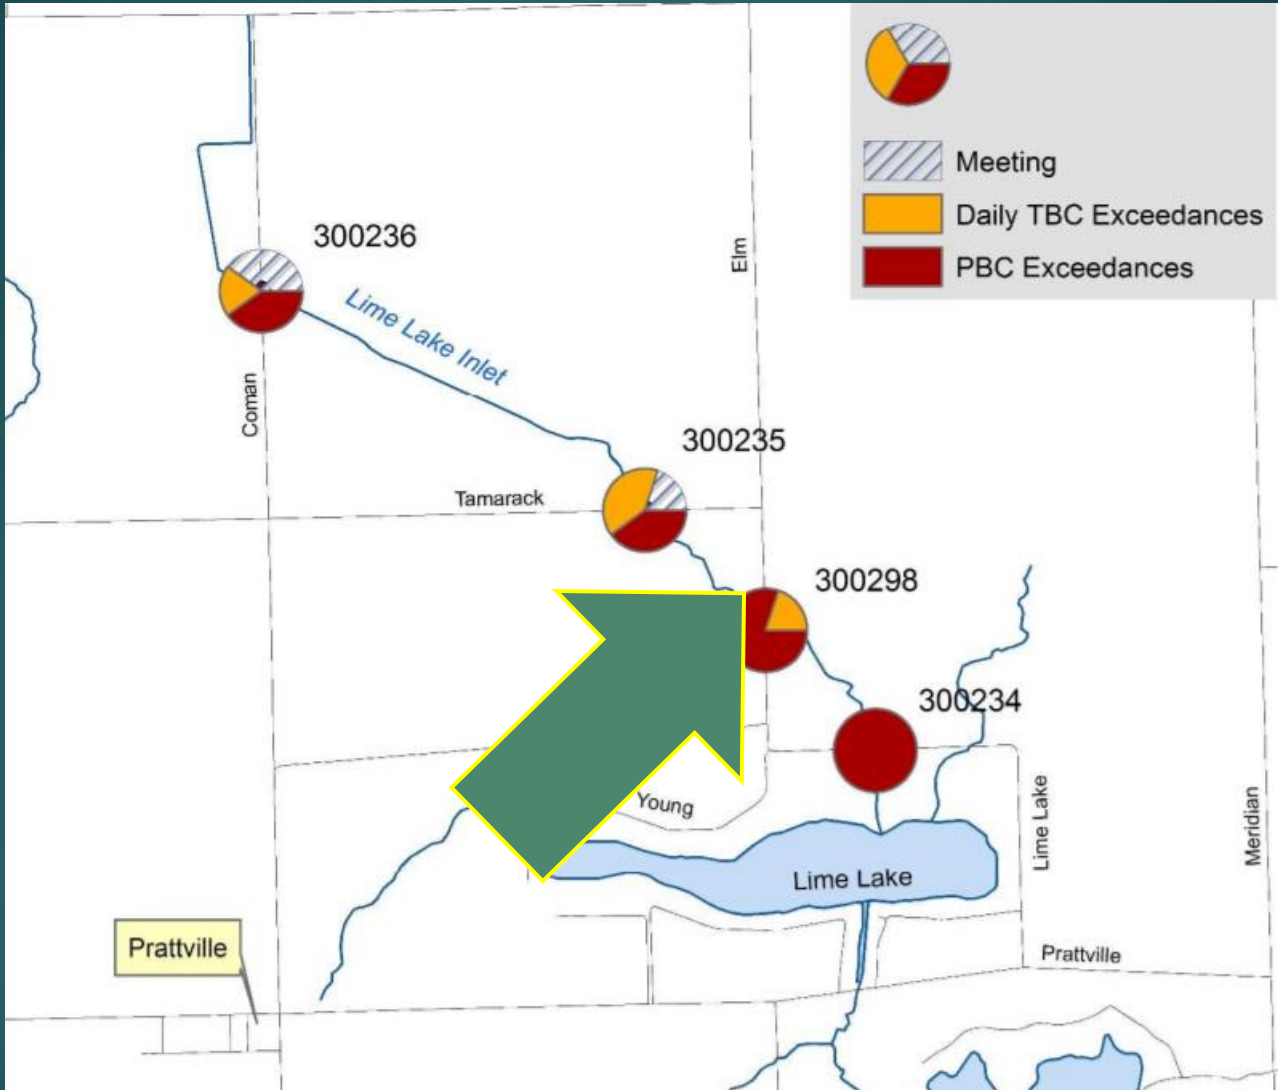
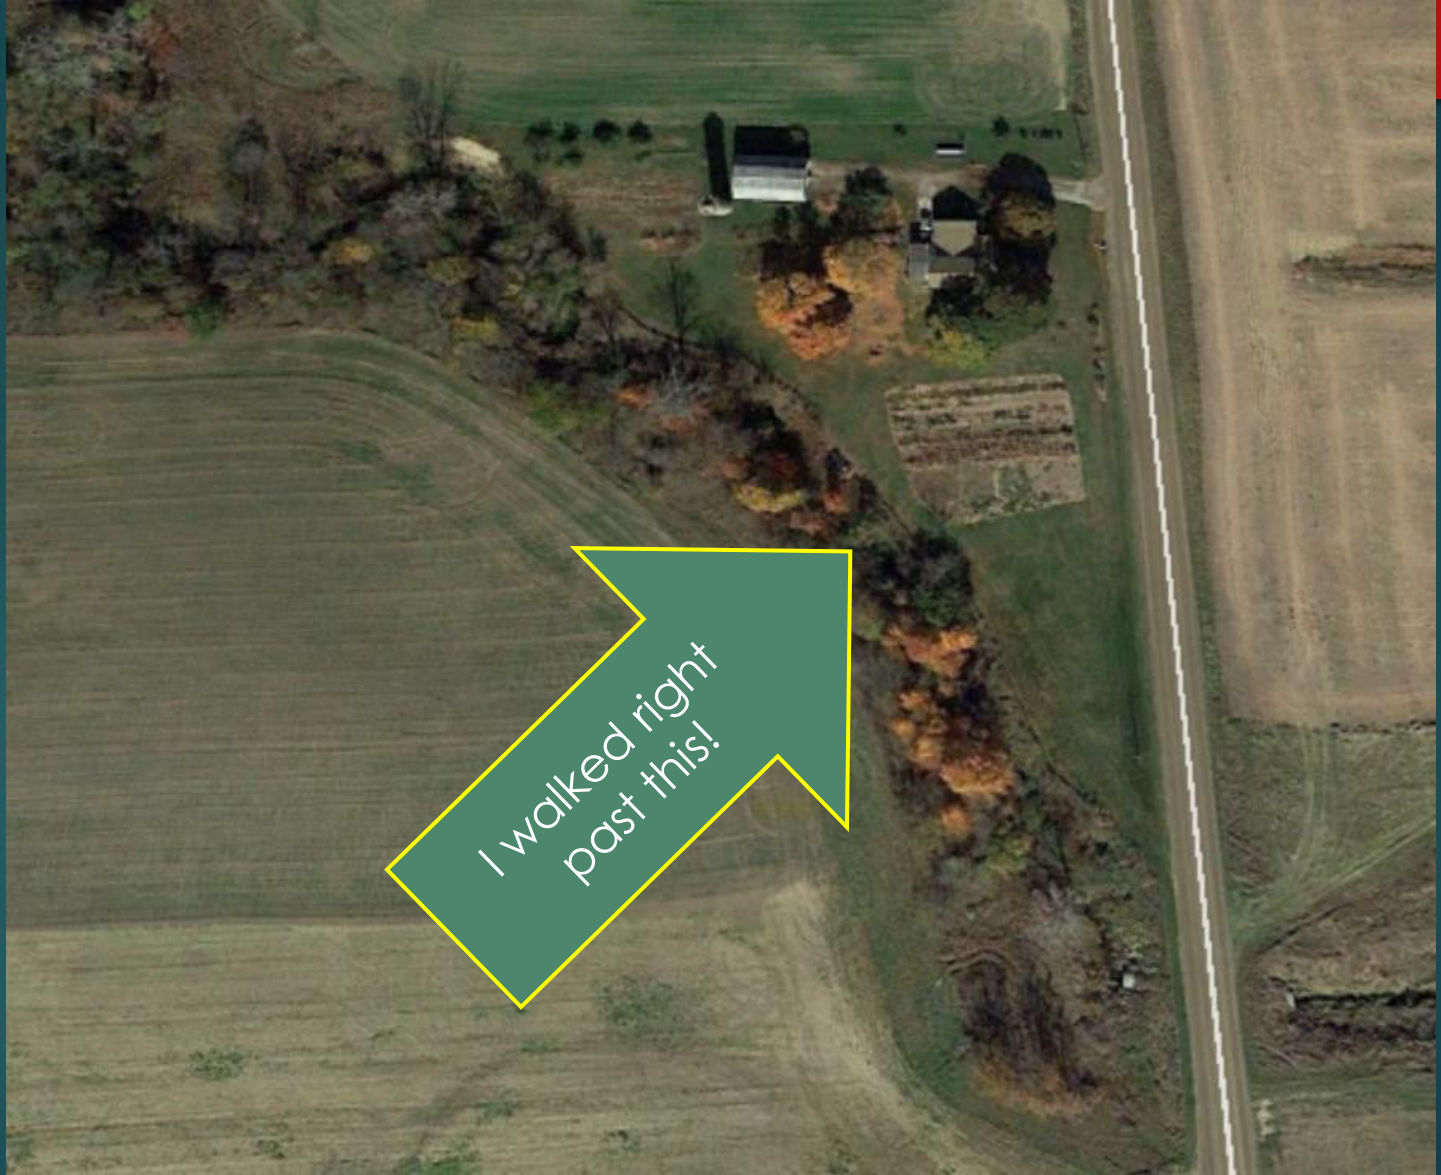
- ▶ We chose properties with **no well/septic permits** on file, which were close to the creek as first priority
 - ▶ The HD conducted those inspections throughout 2017 and found **1 major issue...**

I walked right
past this!

The next issue was funding

- Homeowner couldn't afford a new system
- Local Community Action Agency was able to help

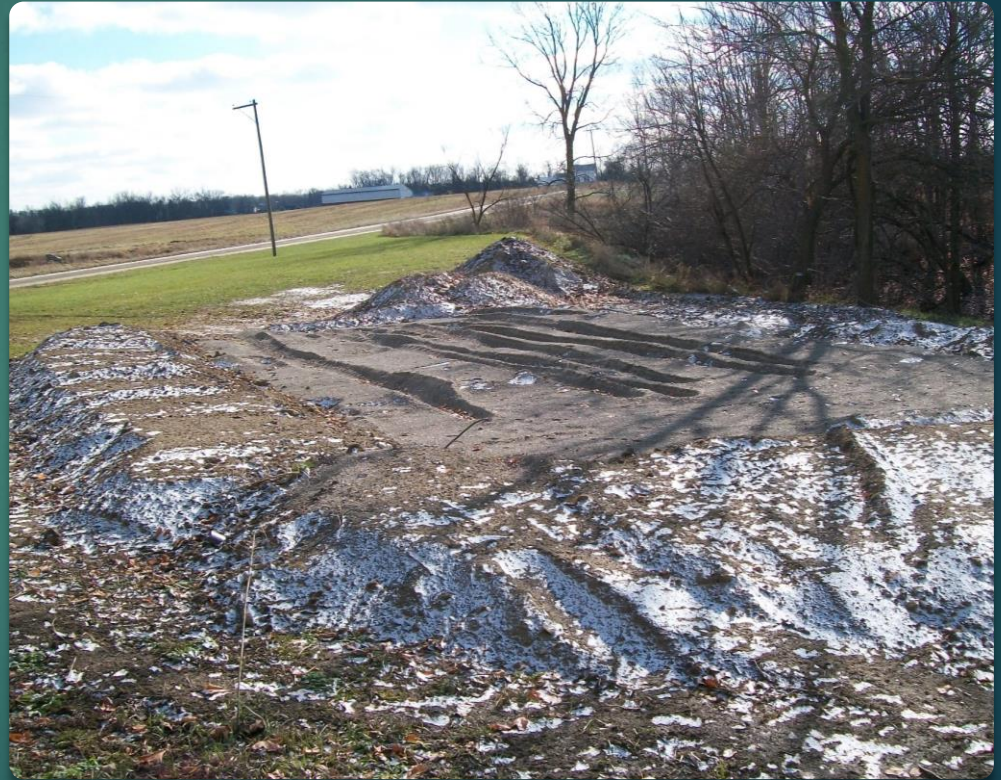
More work to do!
