Ecology's Effectiveness Monitoring Program

2022 National Training Workshop on Water Quality Data, Assessment, and Plans

Scott Collyard (scott.collyard@ecy.wa.gov) Watershed Health and Effectiveness Monitoring Unit Supervisor
and

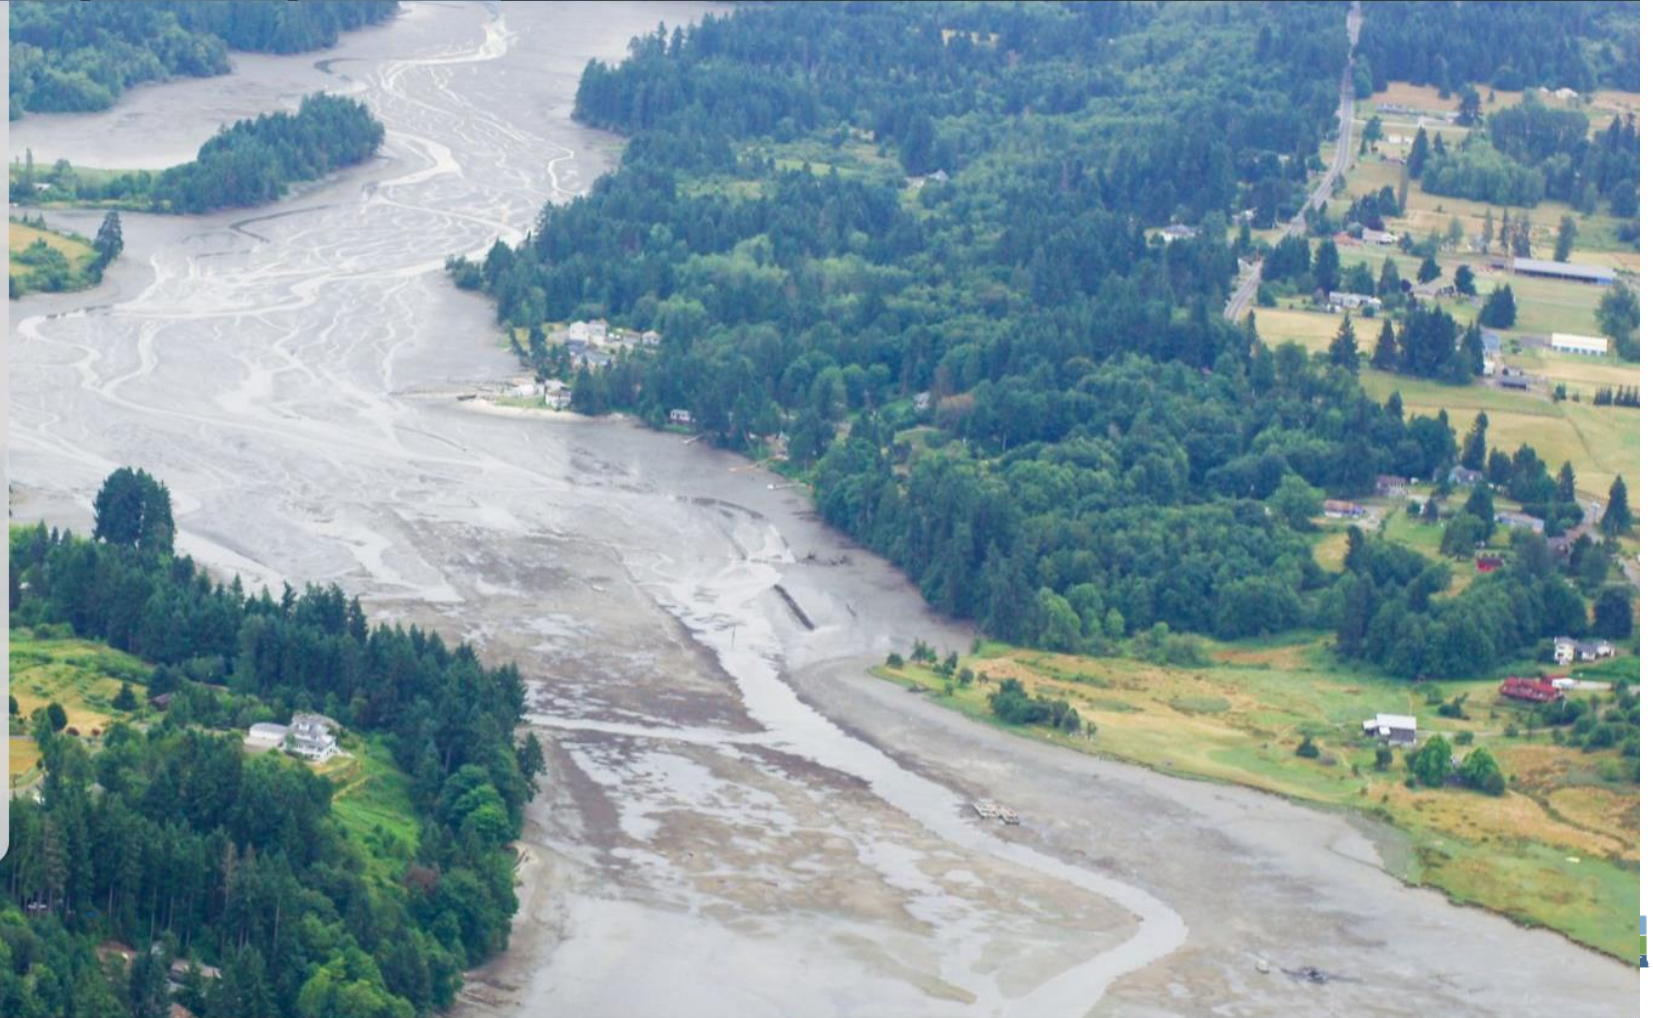
To reduce bacteria levels in Henderson Inlet and its tributaries, local governments and organizations have implemented a wide variety of projects throughout the watershed. Projects like stormwater infrastructure and residential wastewater management have helped to clean up local streams over the last few decades.

This map shows the locations of some of these water quality improvement projects. Each color represents a different type of project as detailed in the legend below. The black dots represent water quality monitoring stations.

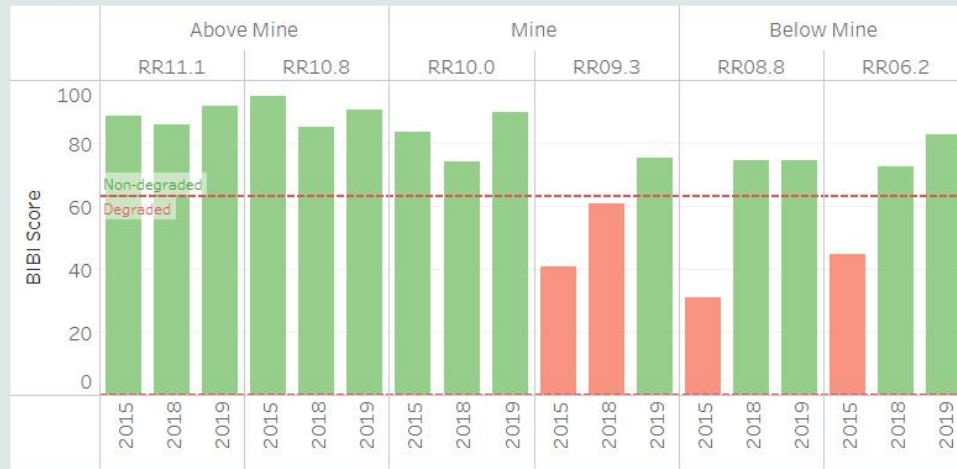
BIBI Scores

Based on [state thresholds for Benthic Index of Biotic Integrity \(B-IBI\)](#) scores, stream biological health remained consistently strong upstream of the mine, but varied more near the mine and downstream. On average, stream biological health improved from 2015 to 2018.

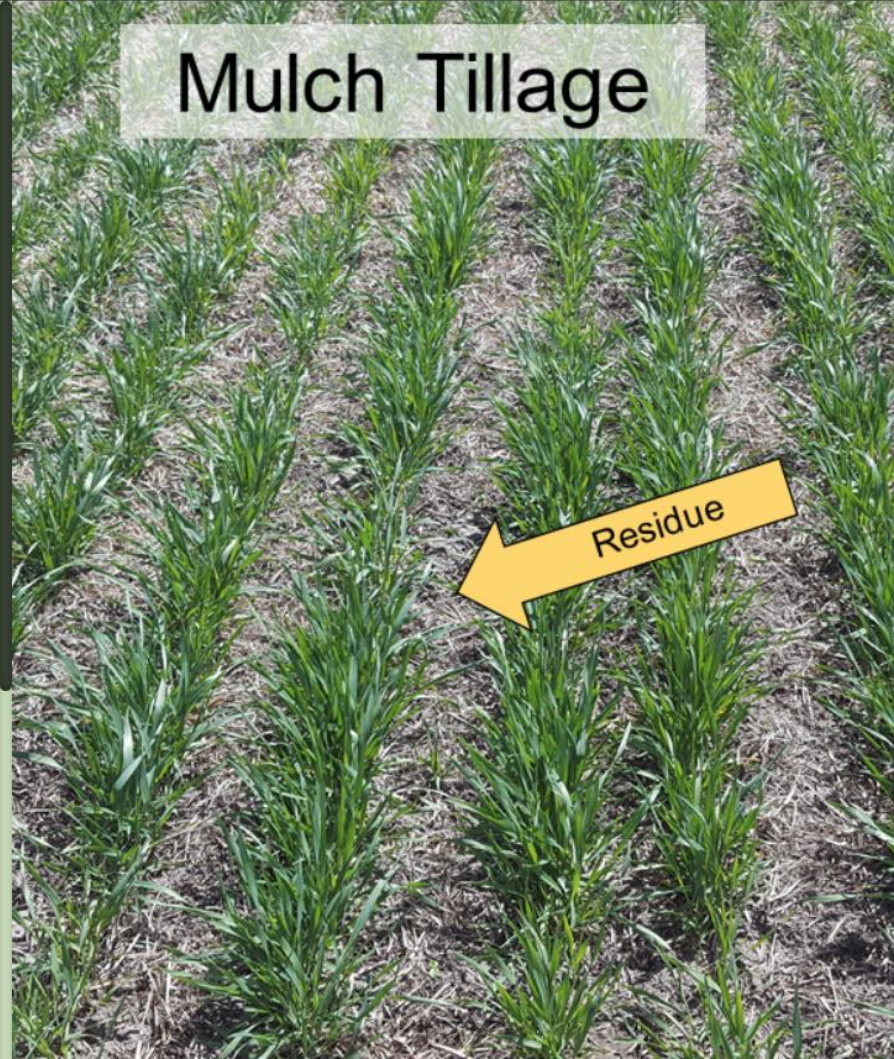
Mulch Tillage

It is estimated that 80% of the agricultural land in the Kamiache Creek watershed, a sub-watershed near St. John, WA, has been converted to mulch tillage. On the contrary, the adjacent Thorn Creek watershed has considerably less of the agricultural land (20%) in conservation tillage, thus serving as a control in this study.
