A Tale of Cows, Dogs, Sewage and Cooperation

Solving Problems in Lime Lake

Molly Rippke – Michigan EGLE

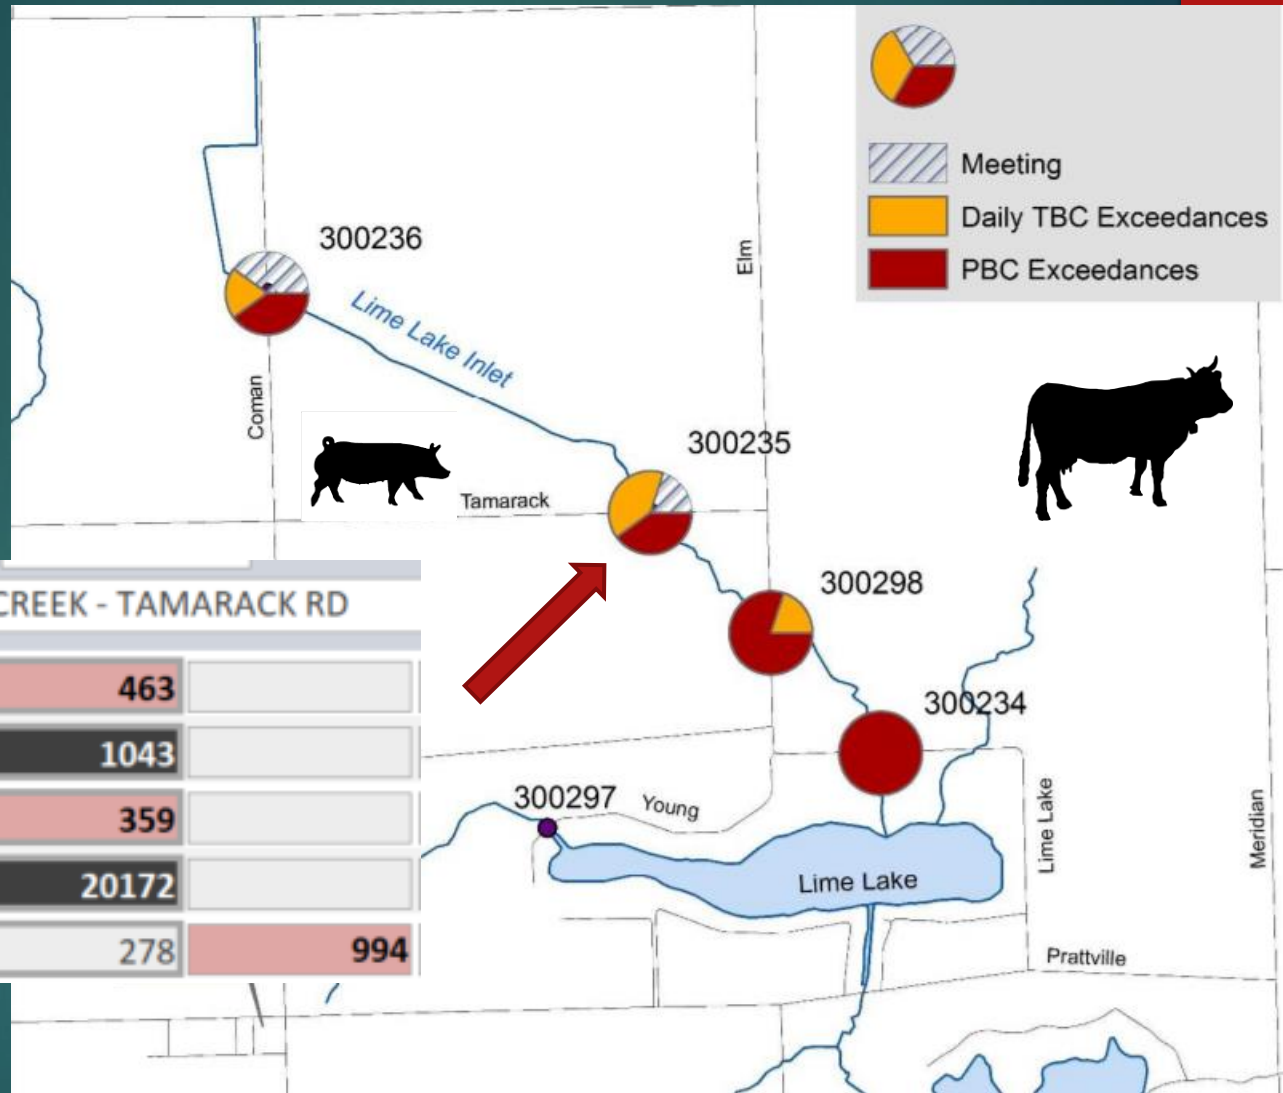
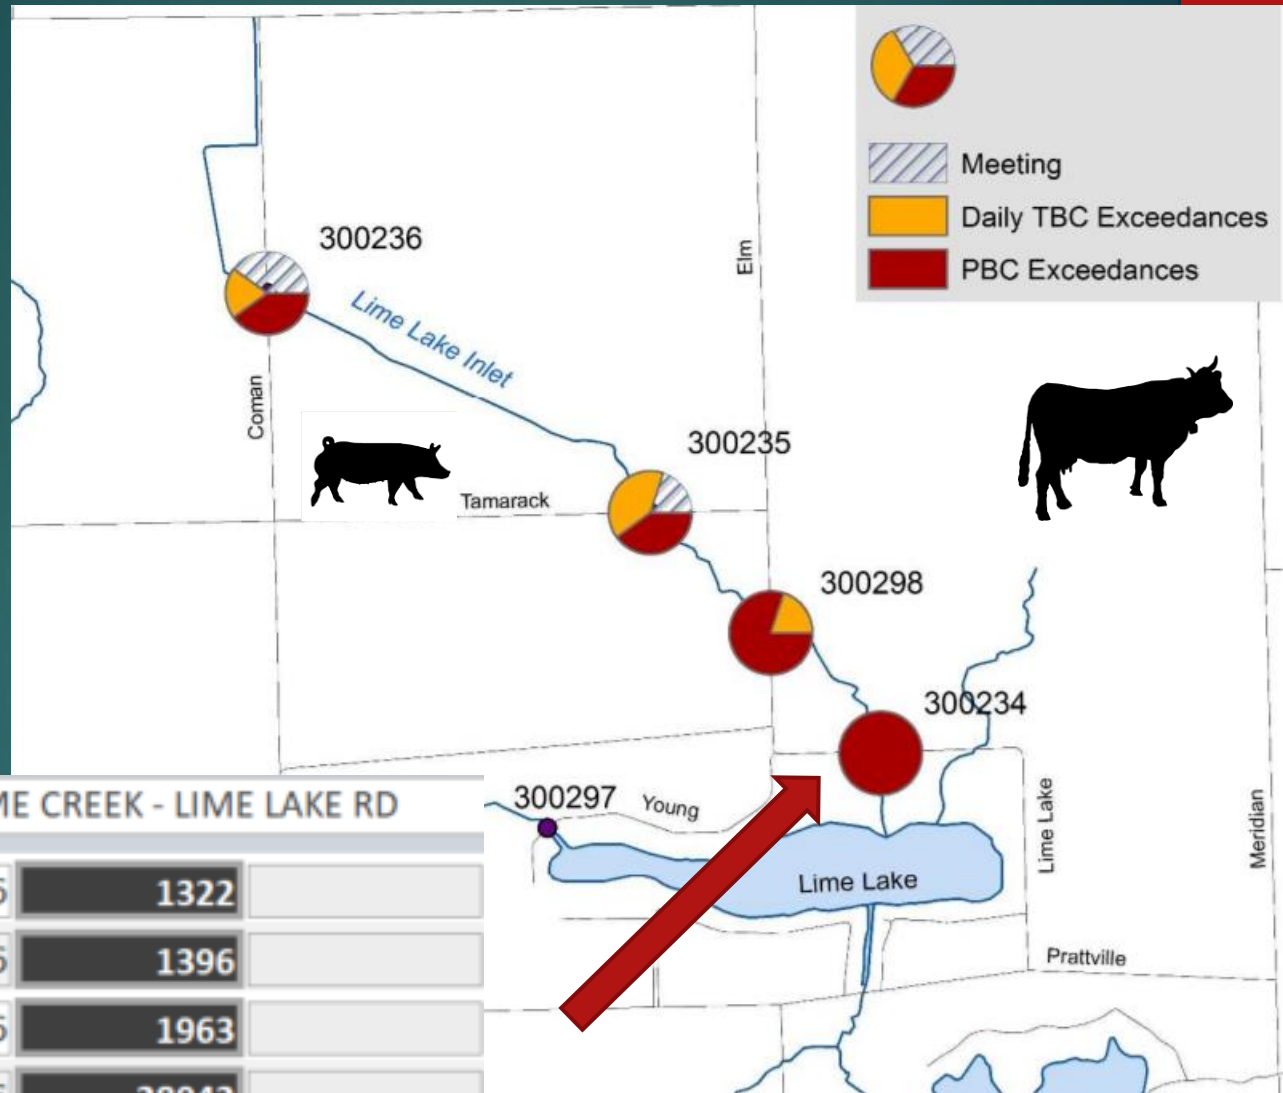
Description	LIME CREEK - LIME LAKE RD	
7/26/2016	1322	
8/2/2016	1396	
8/9/2016	1963	
8/16/2016	28042	
8/23/2016	1498	2732

- ▶ *E. coli* got worse between Tamarack and Elm St, especially during **dry** weather
- ▶ Our 2016 DNA results were **inconclusive (non detects)**, other than one “hit” for pig specific Bacteroides
- ▶ Some limited DNA tracking data collected by a local resident did show “hits” for human, pig, and cow.

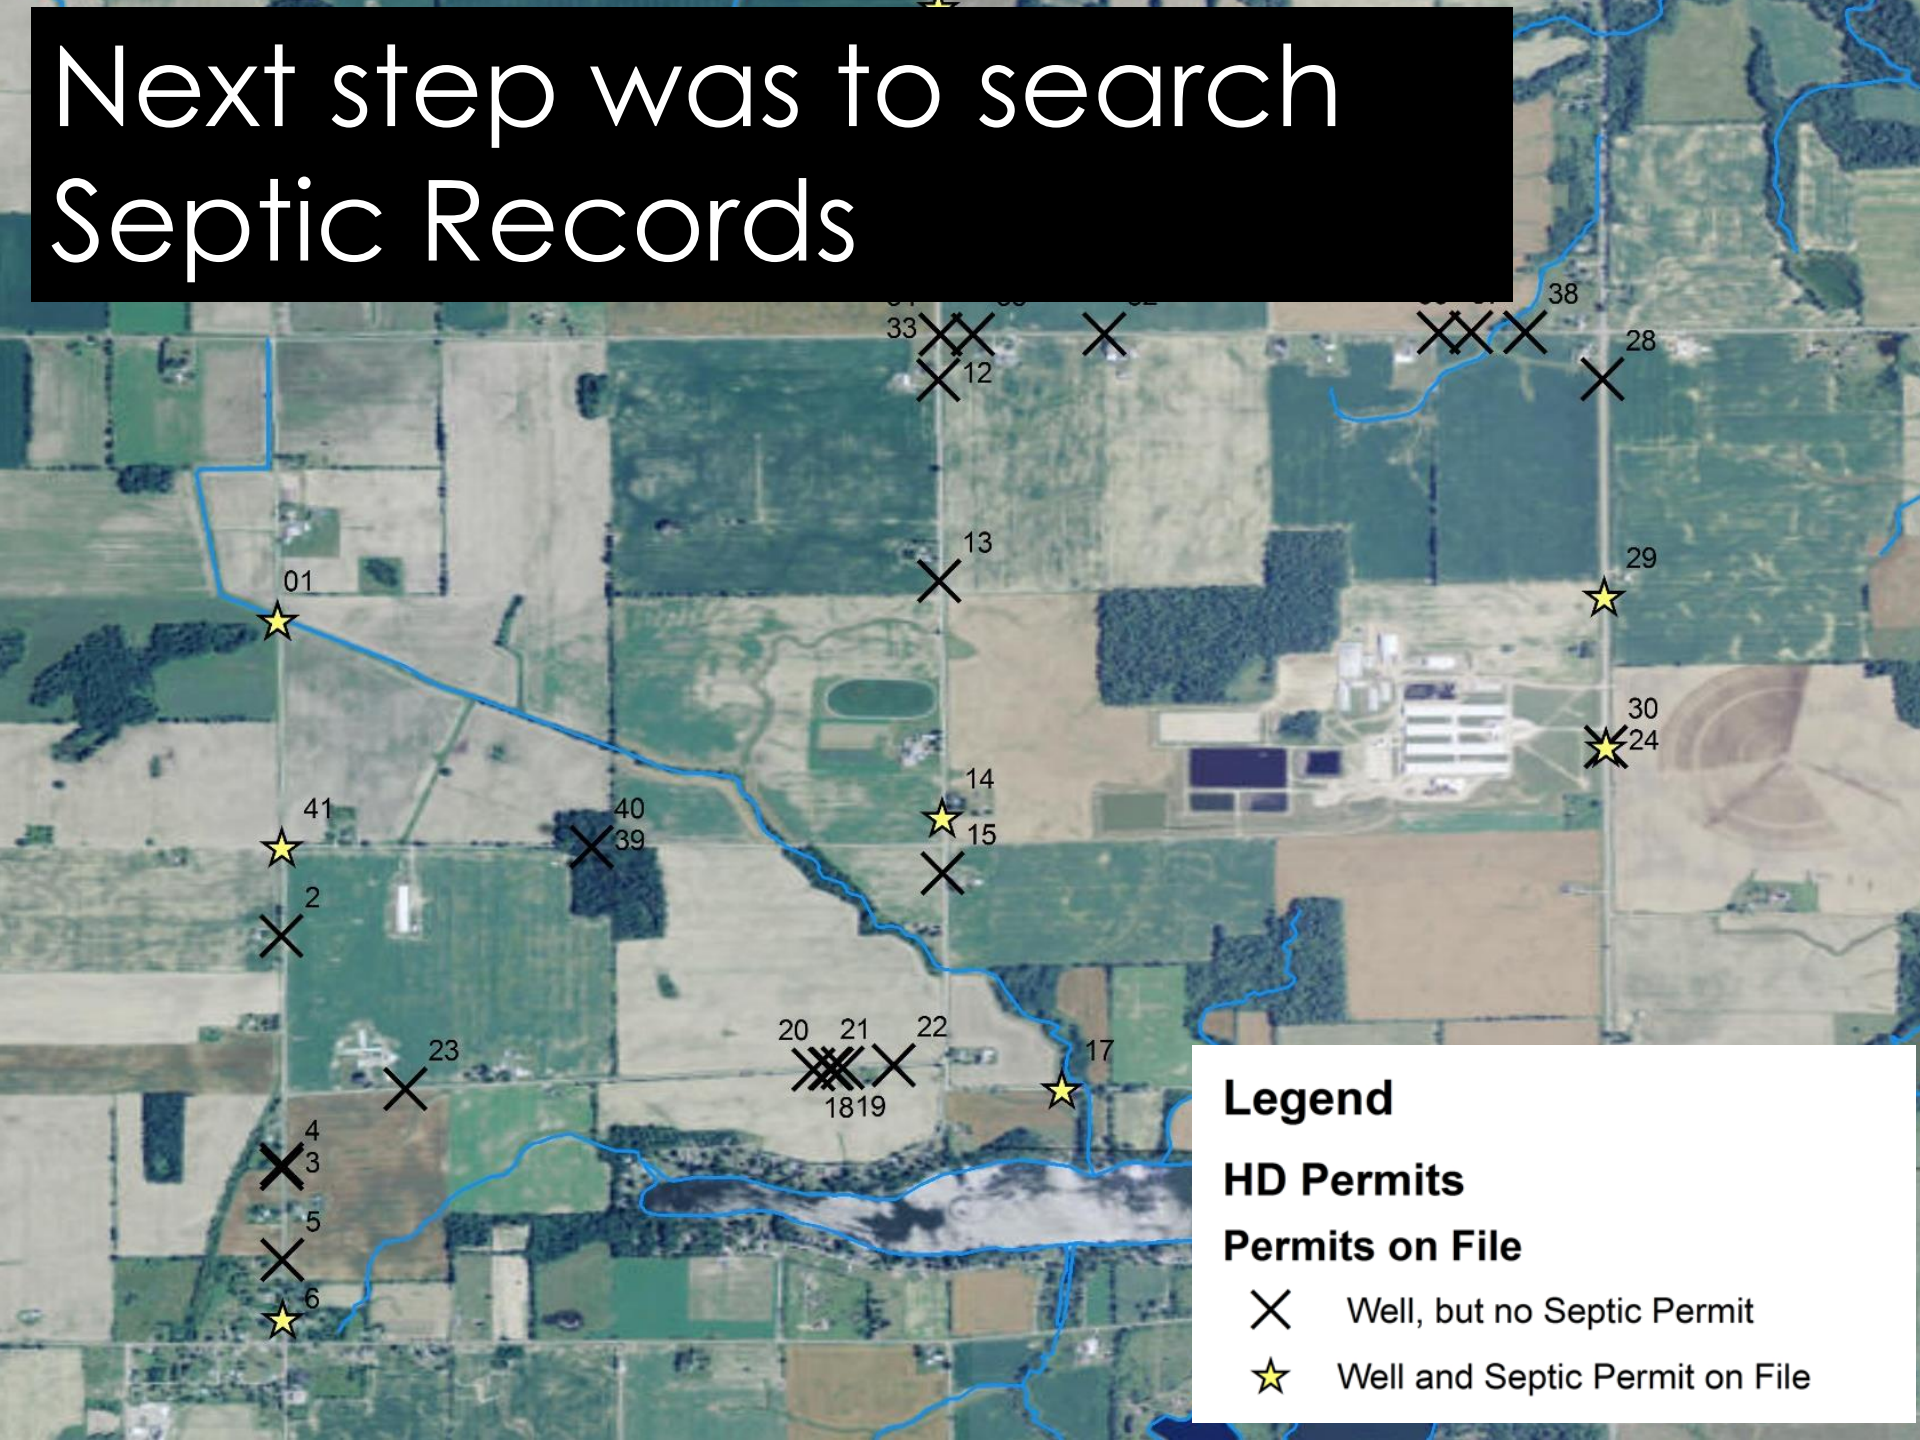
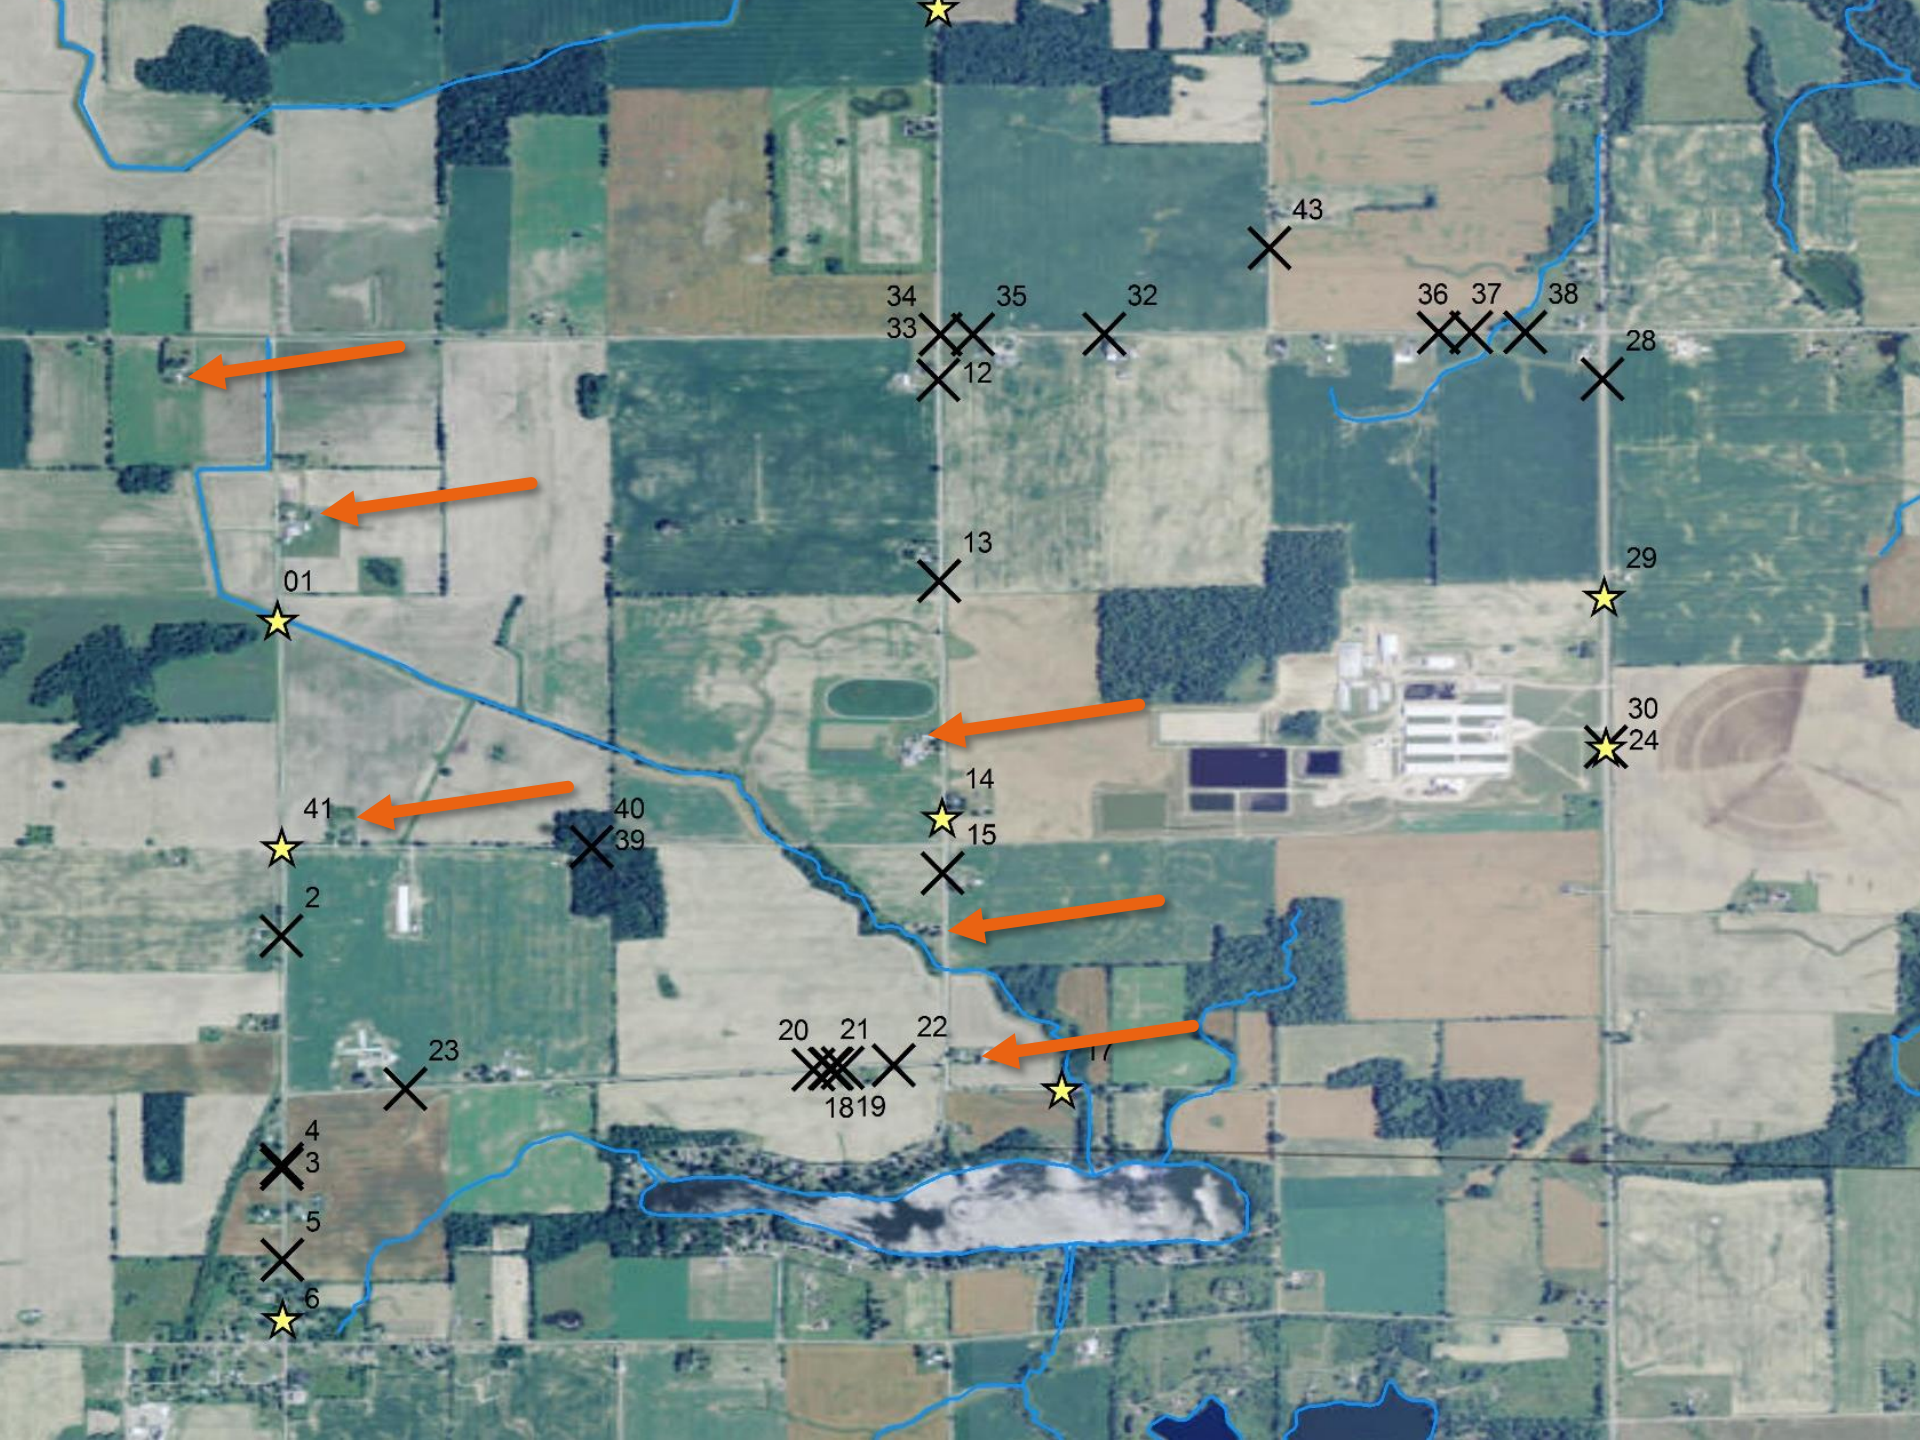
Next step was to search Septic Records

- ▶ We chose properties with **no well/septic permits** on file, which were close to the creek as first priority
 - ▶ The HD conducted those inspections throughout 2017 and found **1 major issue...**
